Manhole Inspection Summary

Manhole # S02WW1005MH

Insp Date: **7/27/06 7:47 AM**

Location Address: **6303 Fieldcrest Rd**

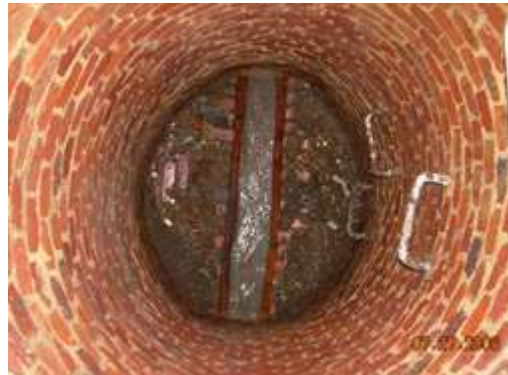
Top View

Condition: ☐ Sound ☐ Cracked ☐ Root Intrusion ☒ **Loose Brick** ☐ Deteriorated

Condition: ☐ Sound ☐ Cracked ☐ Root Intrusion ☐ Deteriorated ☐ Leaks ☒ **Debris**

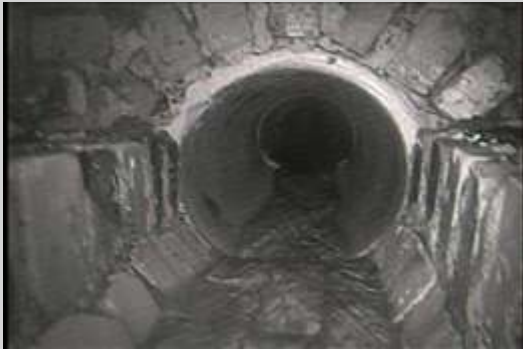
10 in. Circular Gravity Sewer Pipe Out @ 12 O'Clock

Rod and Bar (Angled)

Pipe Material: **Clay** ☐ Pipe Lined

Invert Depth: **10.83** (ft.) Flow Characteristics: **Fast**

Infiltration: **None** Pipe Seal Cond: **Sound**

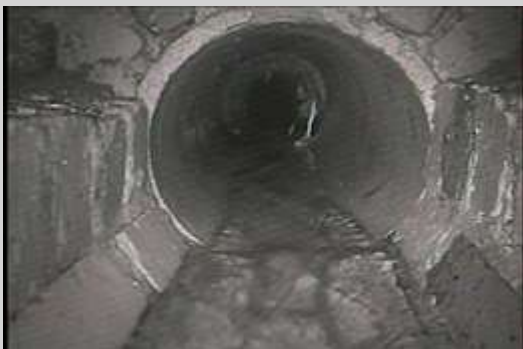
10 in. Circular Gravity Sewer Pipe In @ 6 O'Clock

Rod and Bar (Angled)

Pipe Material: **Clay** ☐ Pipe Lined

Invert Depth: **10.77** (ft.) Flow Characteristics: **Fast**

Infiltration: **None** Pipe Seal Cond: **Sound**

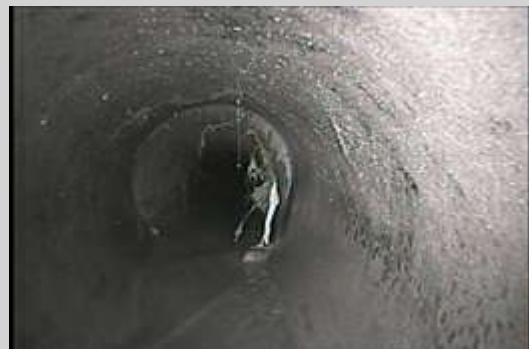
Pipe In @ 6 O'Clock

Light Roots
